Rebuilding a degraded RAID array

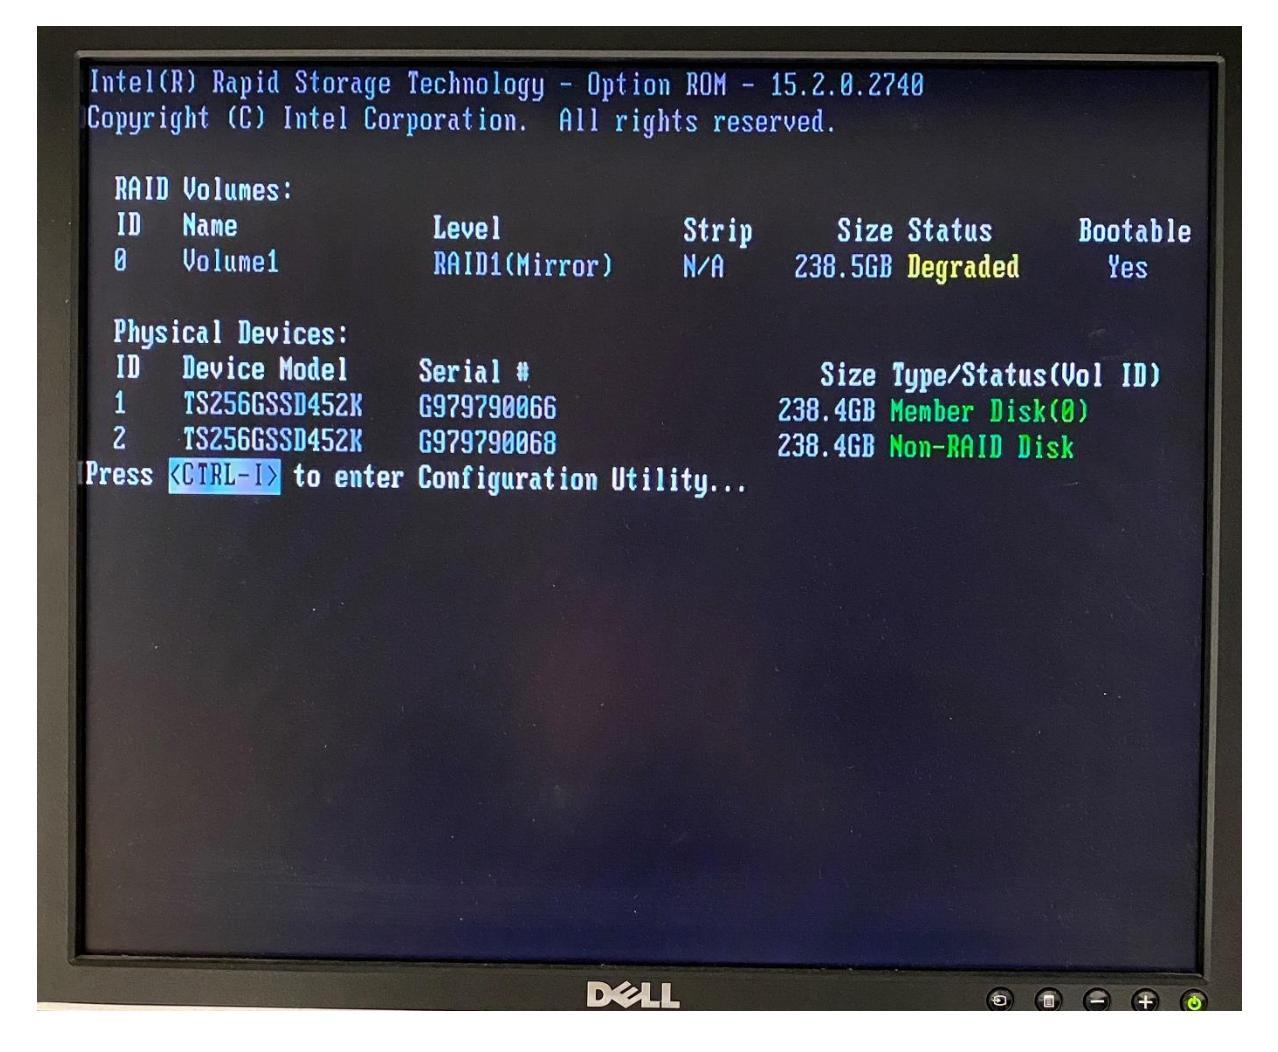
After installing the new SSD, you will see the following screen at startup:

Press Ctrl+I to enter the RAID configuration utility.

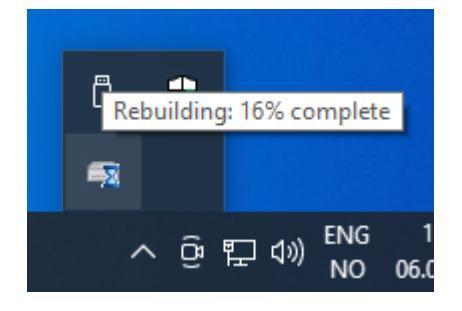
In Windows, the Intel RST GUI will show the rebuilding progress:

In addition to the notifications in system tray:
